Manston Airport Development Consent Order 2018 Consultation

**Preliminary Environmental
Information Report (PEIR)**

Volume VI

Appendices 7.6-9.5

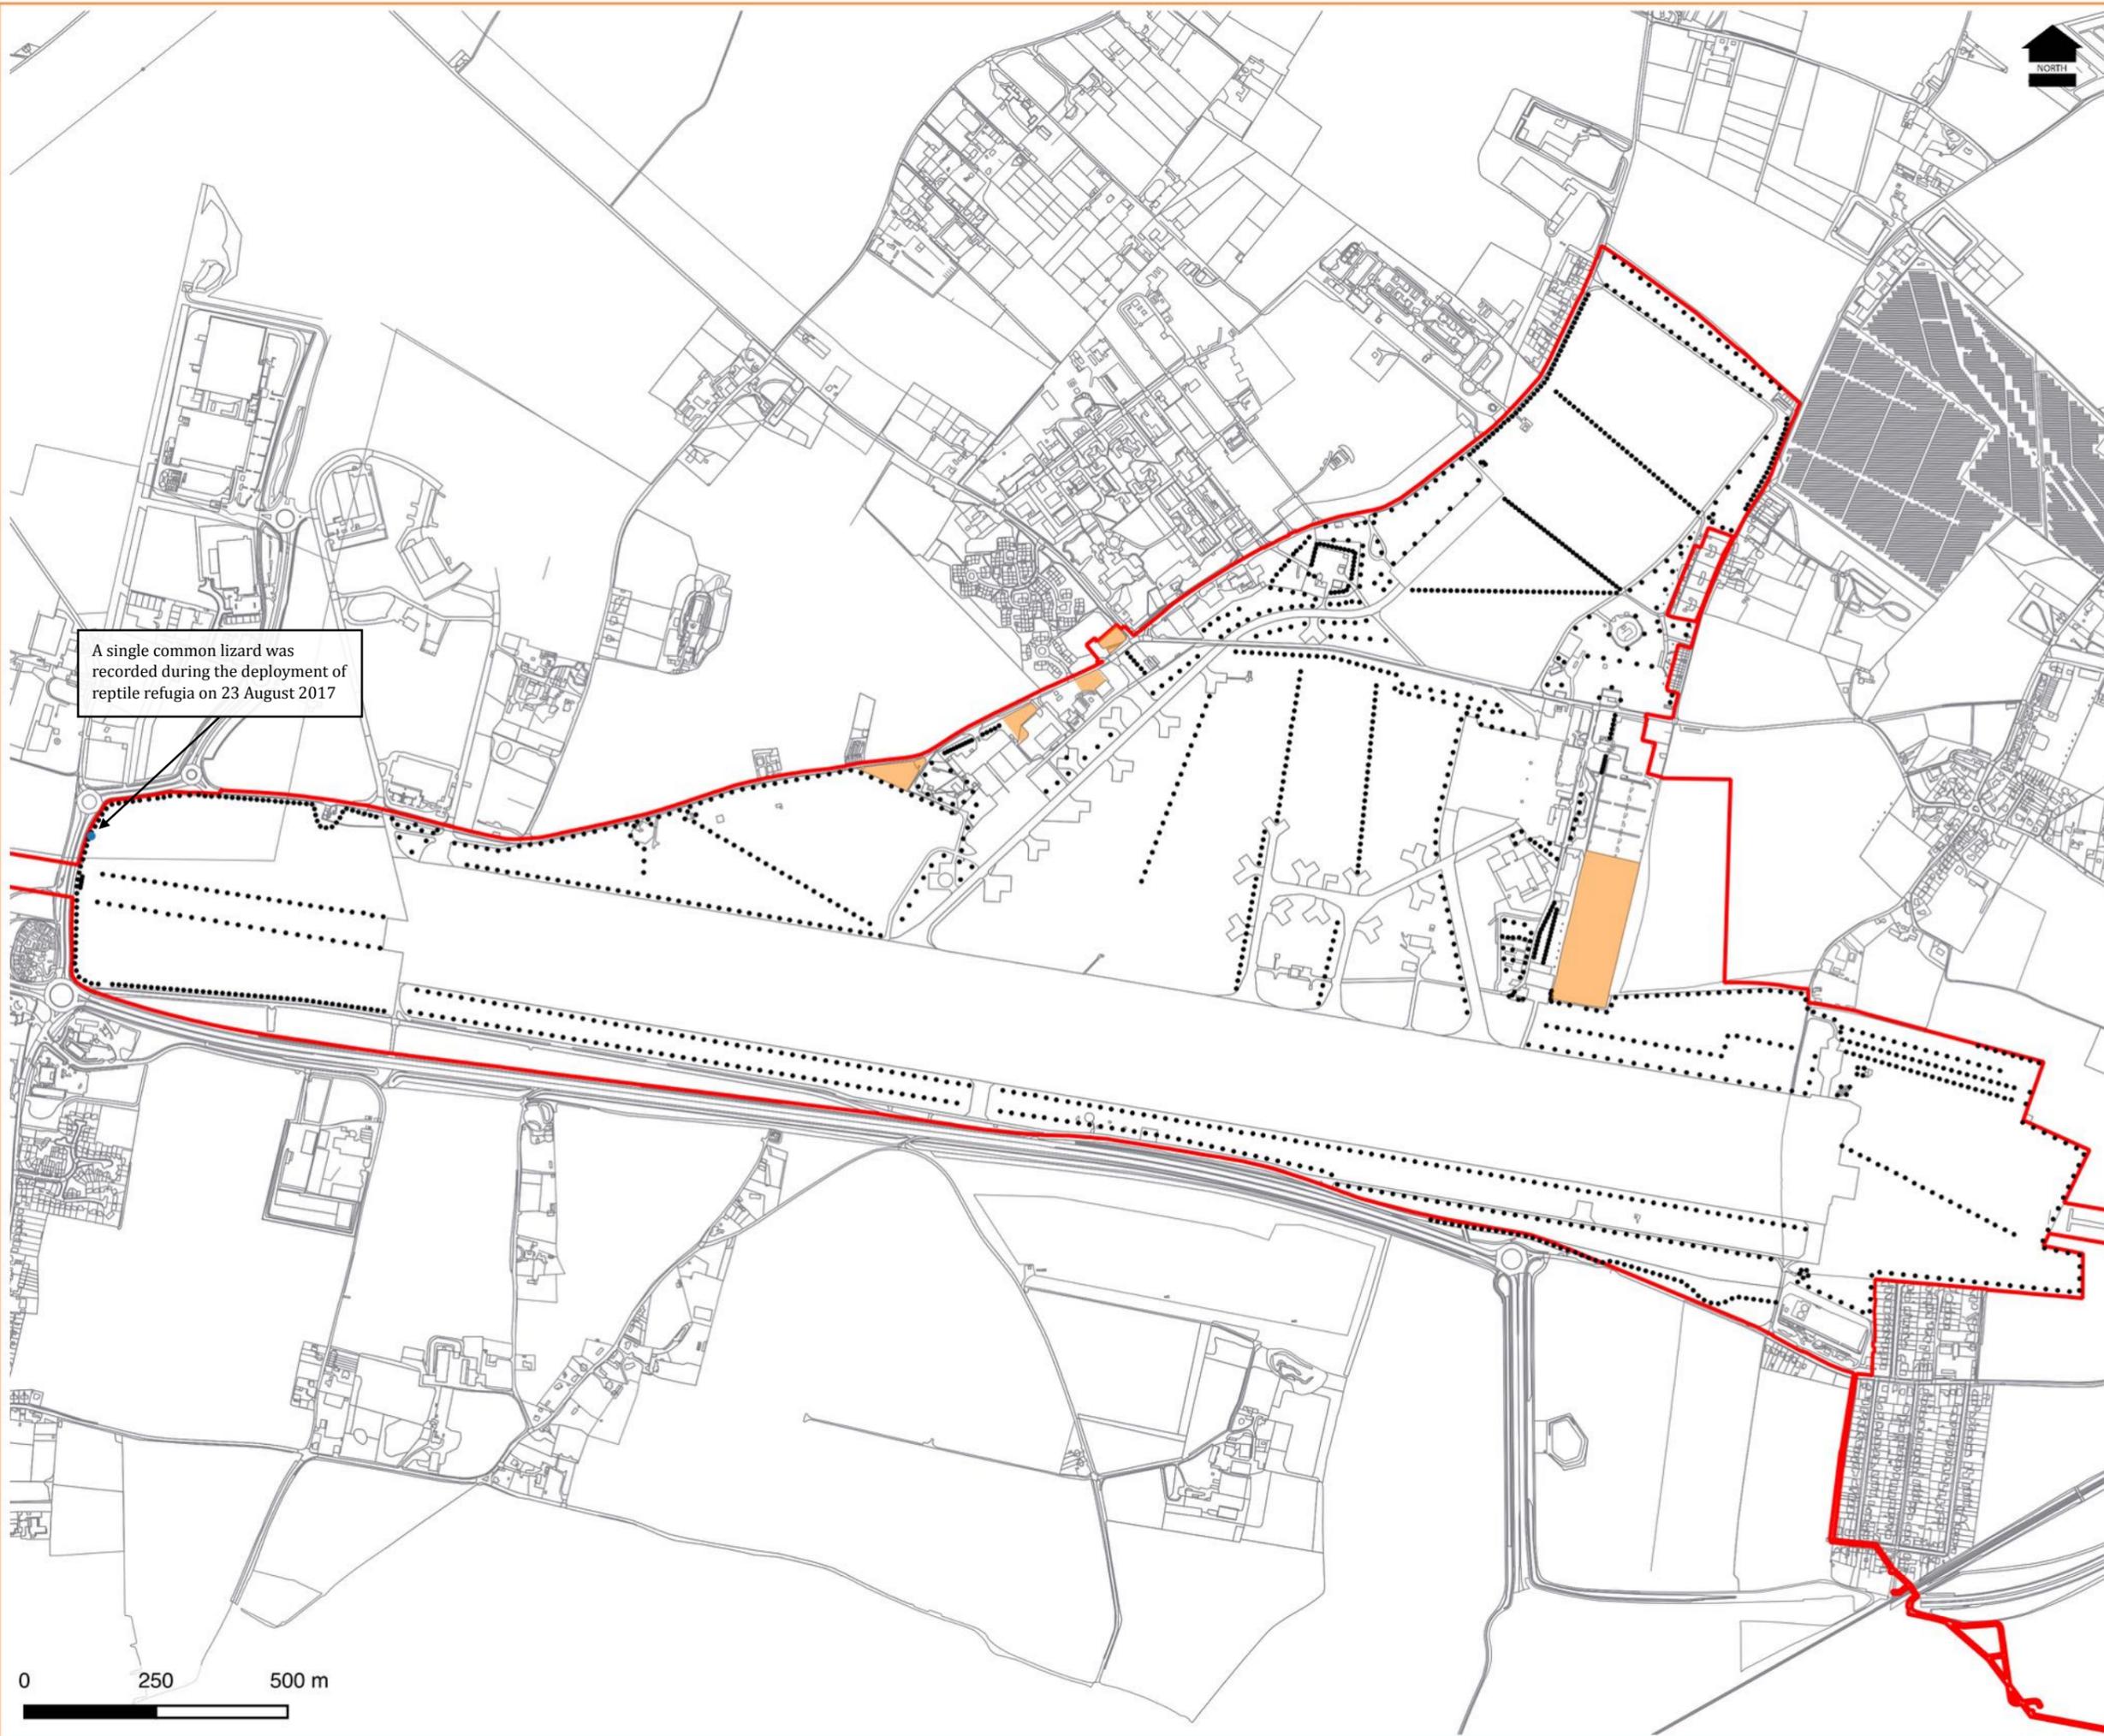
Figure 2.
Results of the reptile survey

- 4.1.1** A single adult common lizard was recorded basking within the site (along the western site boundary, adjacent to Minster Road) during felt/tin placement on 23 August 2017, see Figure 2 in Appendix A. No reptiles were recorded during any of the seven reptile checks.
- 4.1.2** As set out in Appendix B, the reptile checks were undertaken in optimal or suitable weather conditions in September, which is considered to be an optimal time of year to conduct this type of survey.

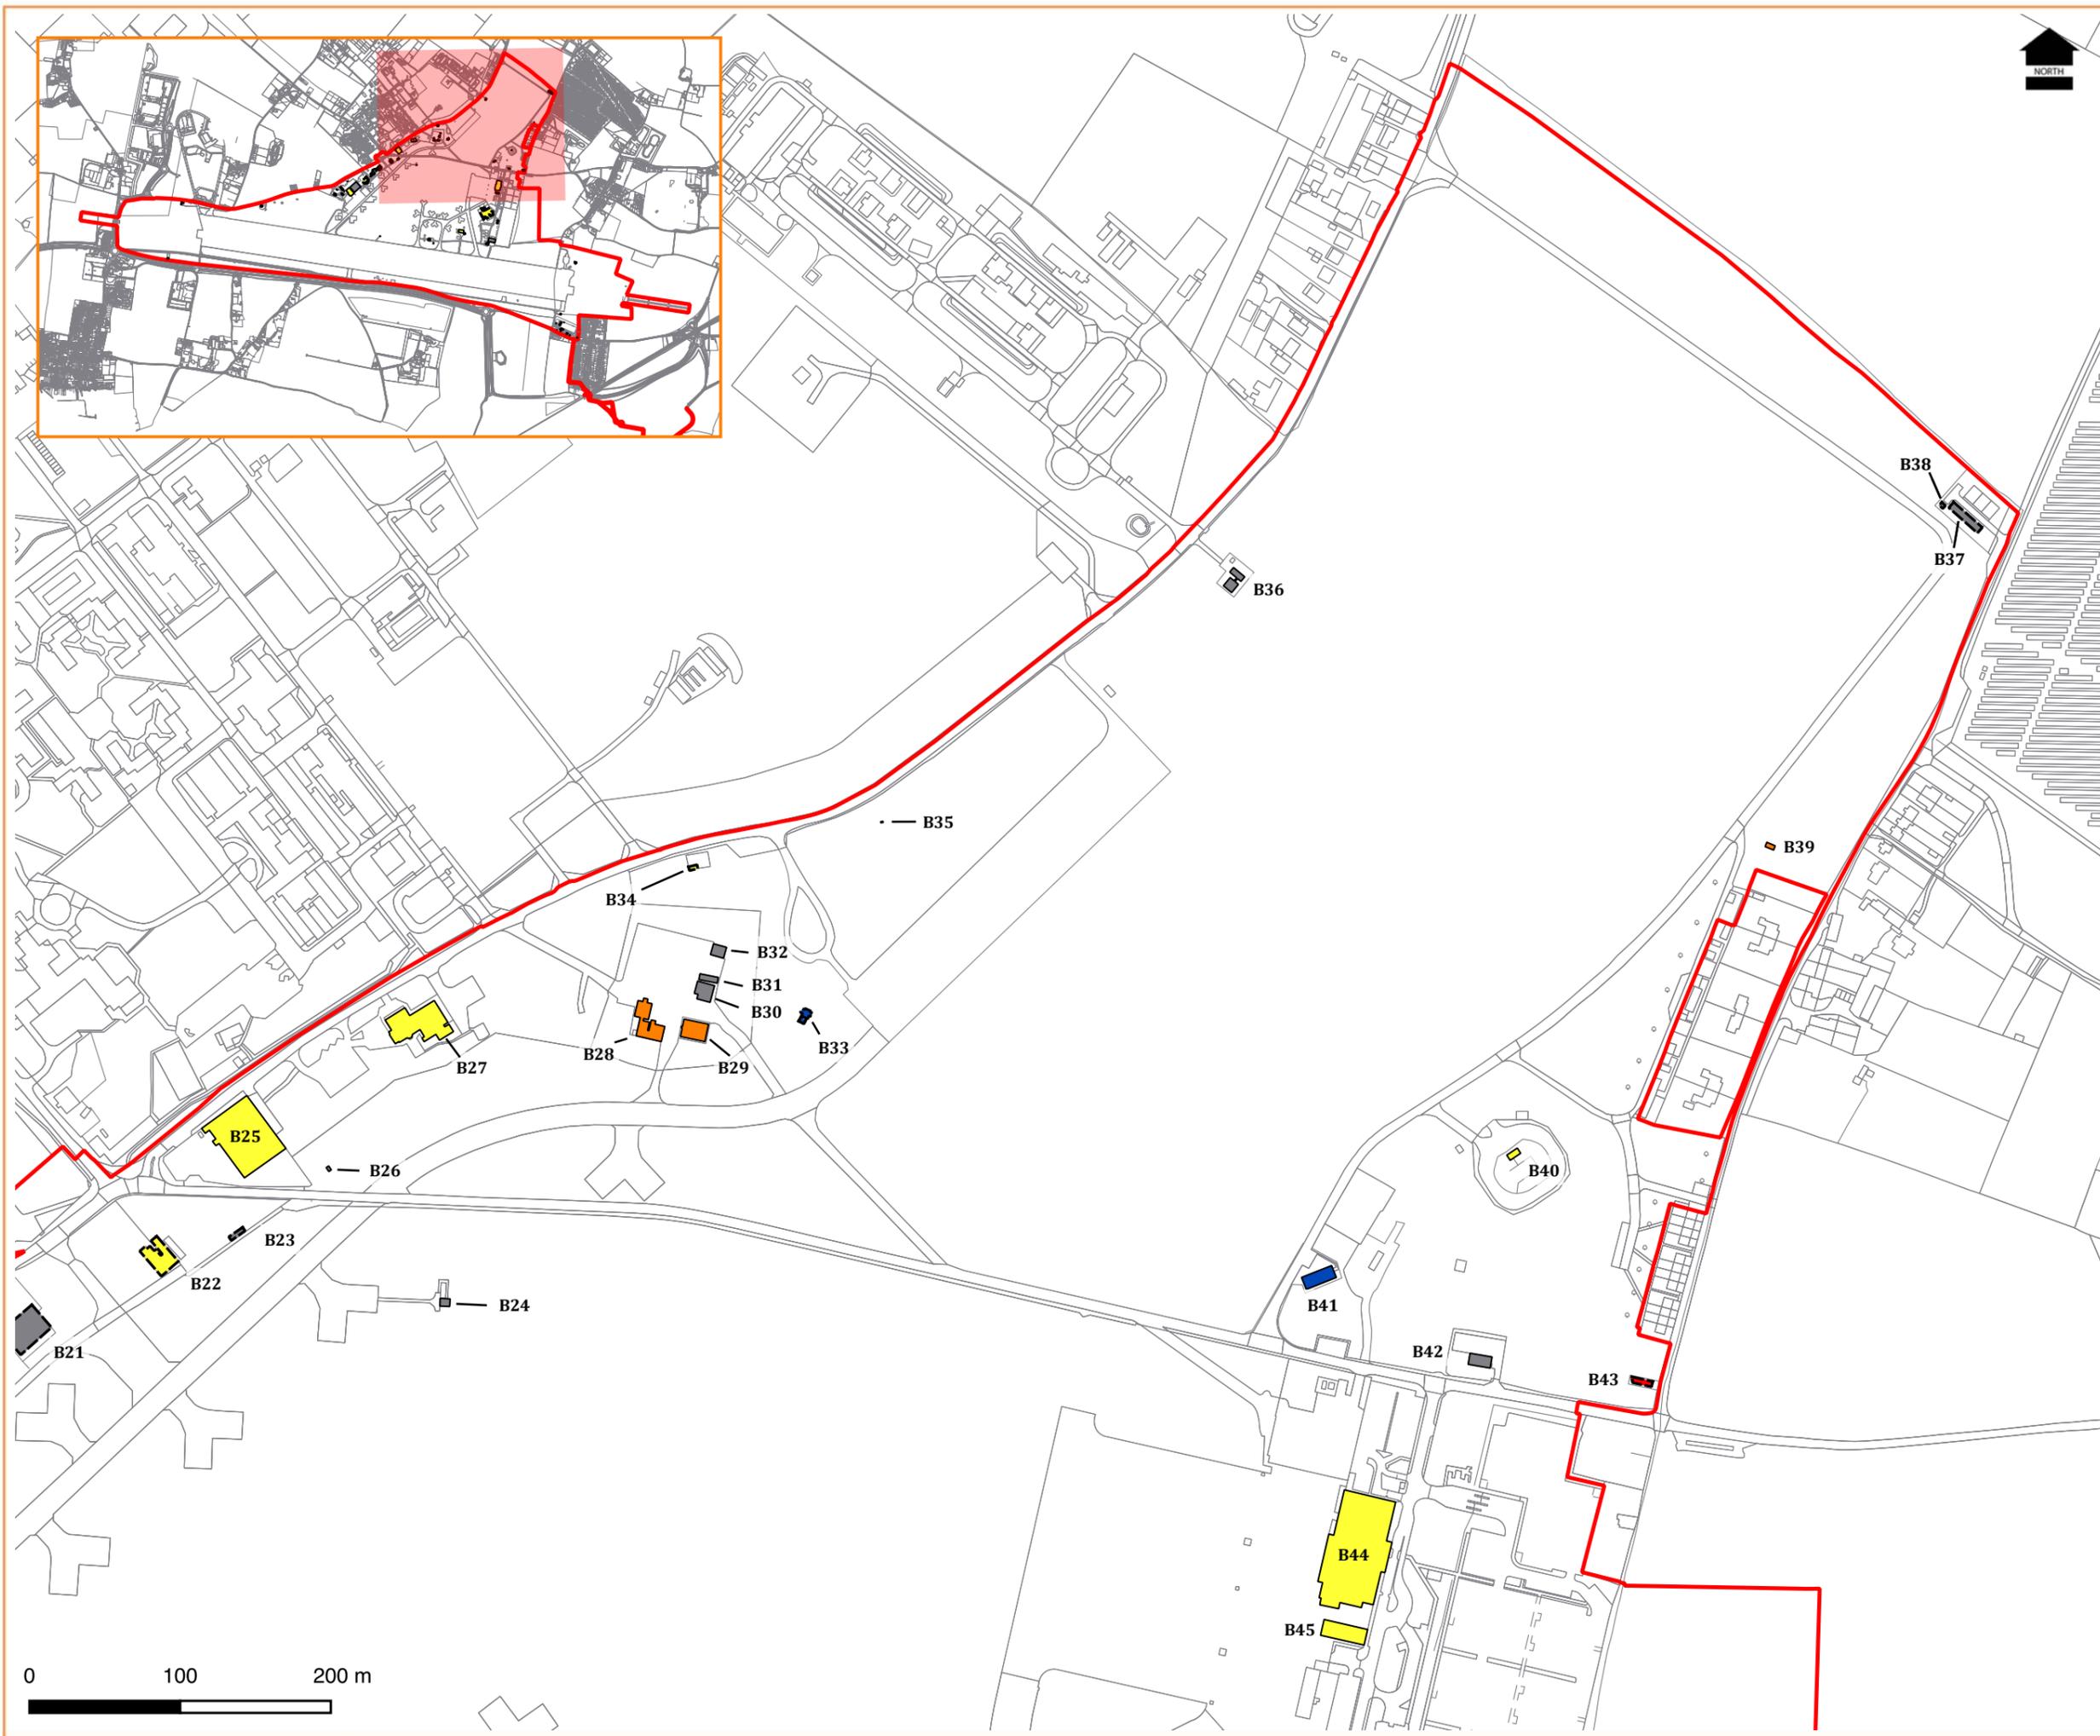
Figure 3b.

Results of the building inspection for bats

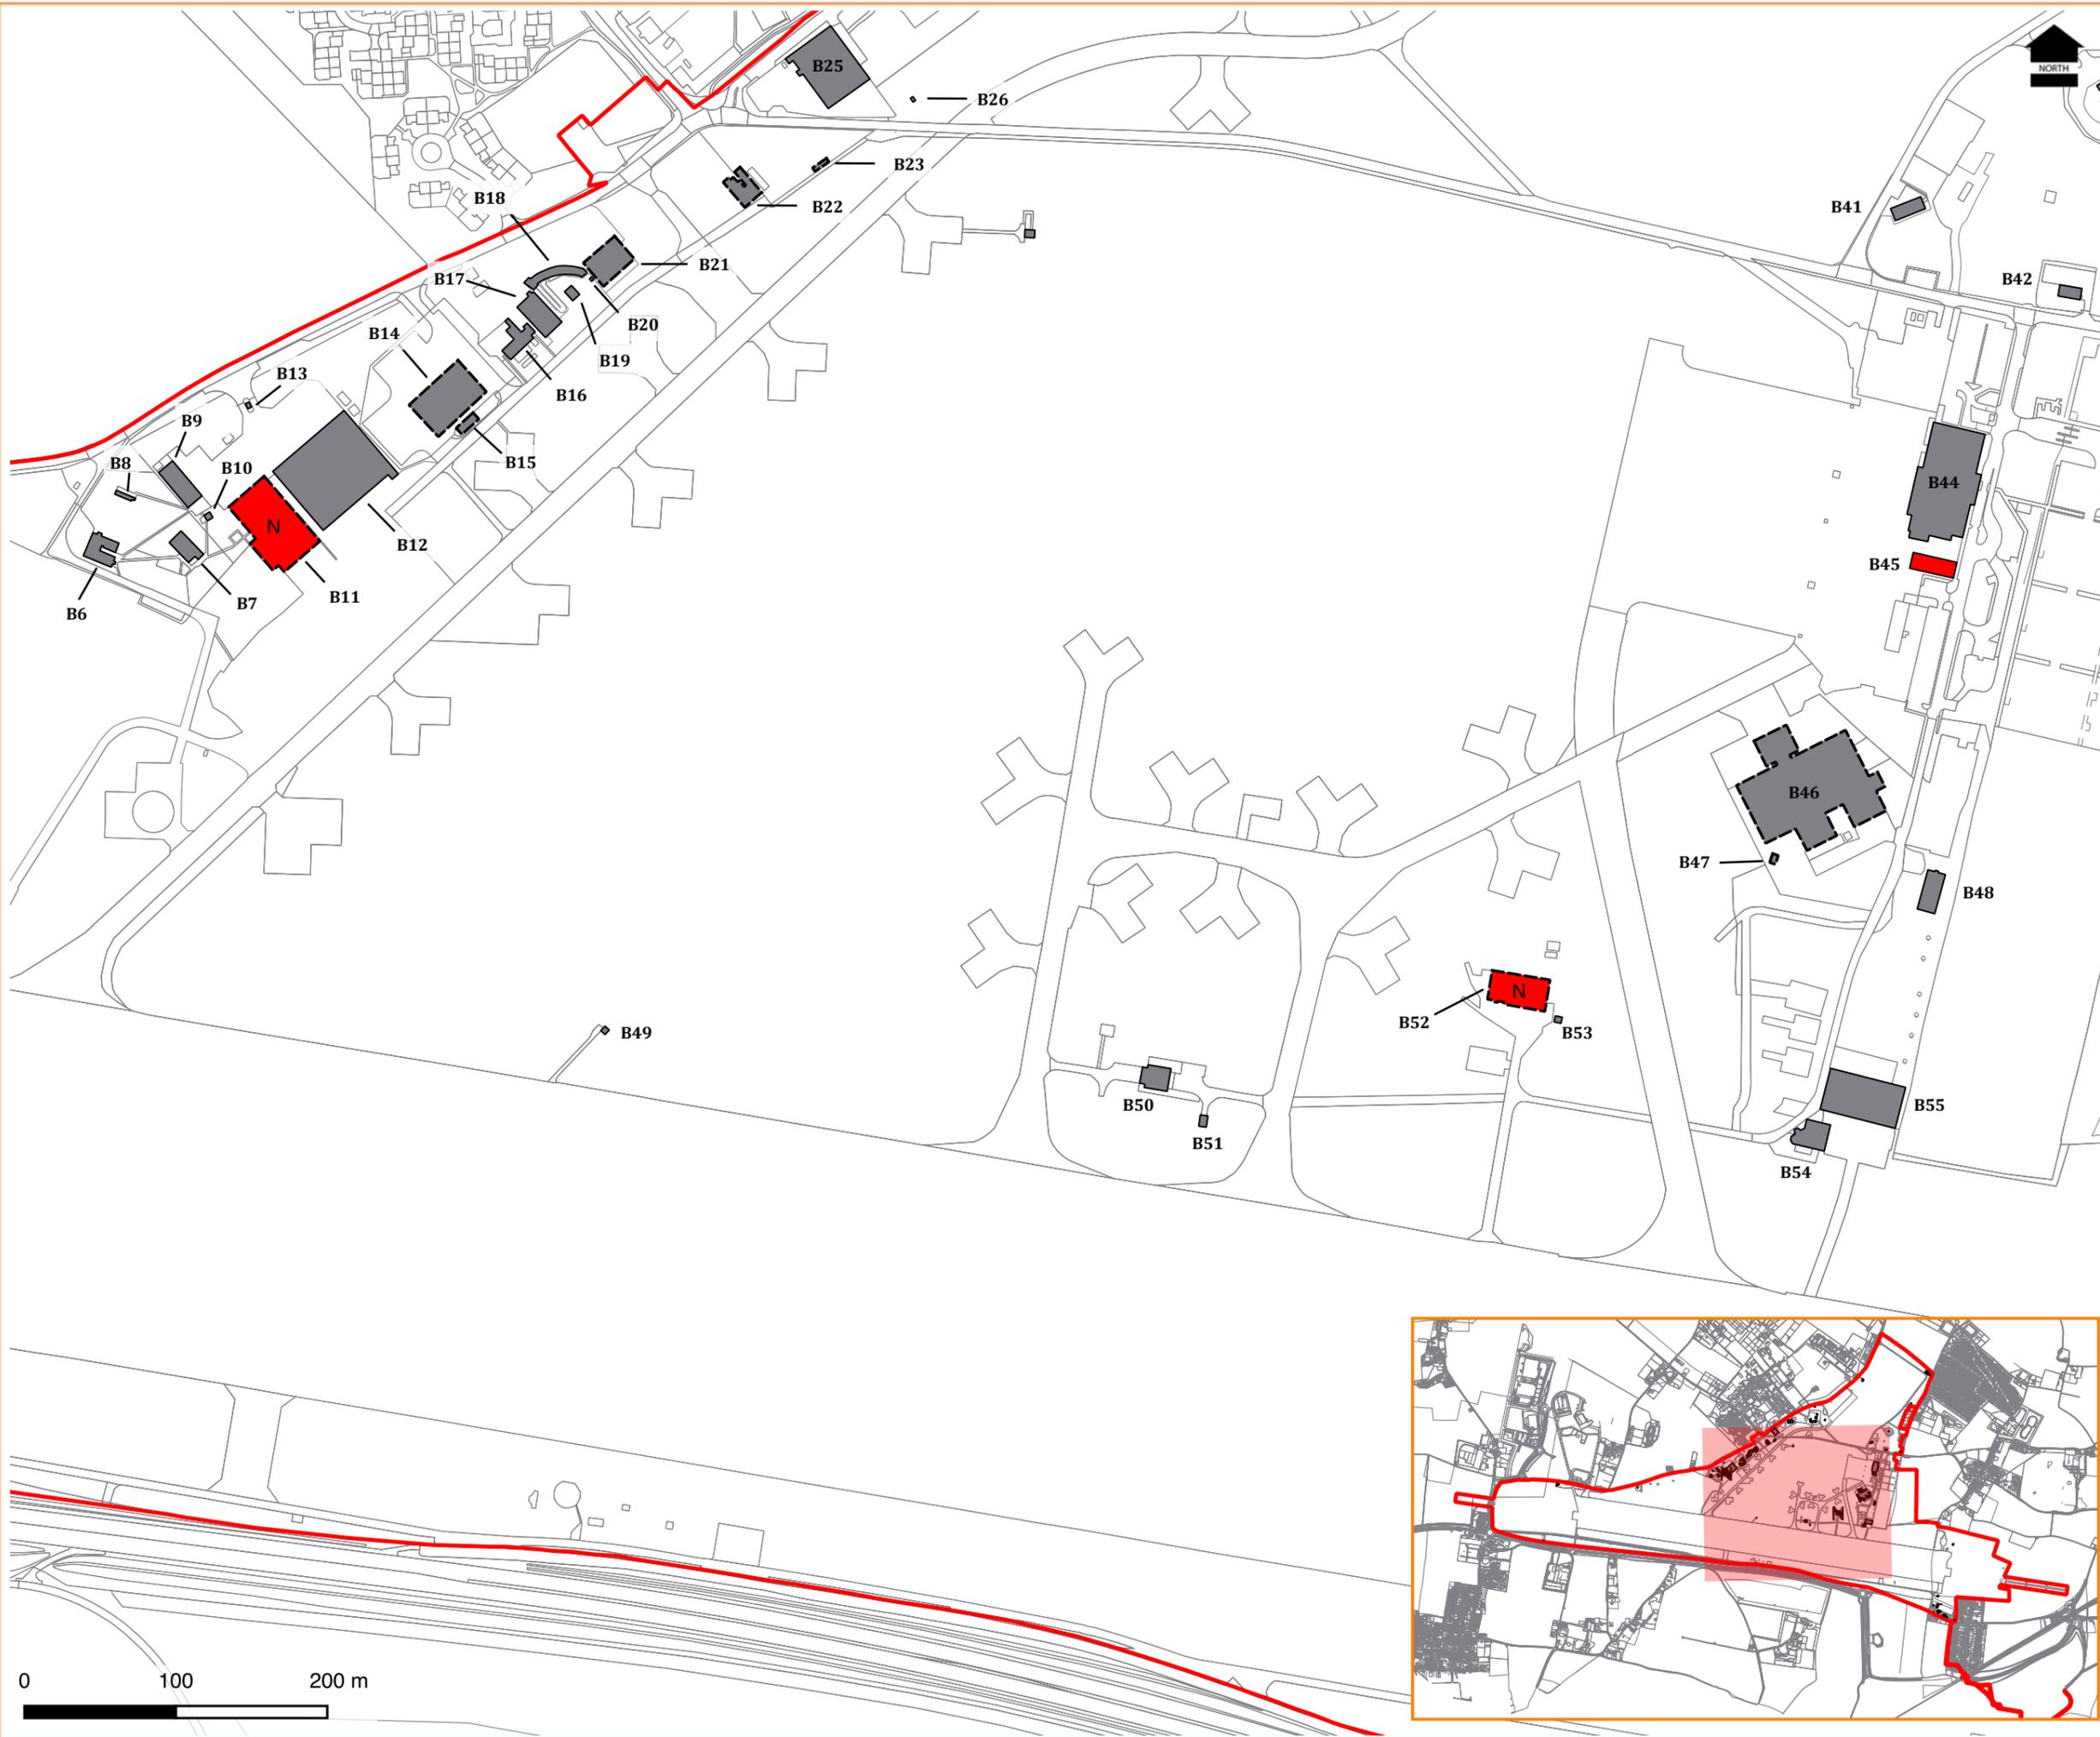
Figure 4b.

Results of the building inspection for barn owls

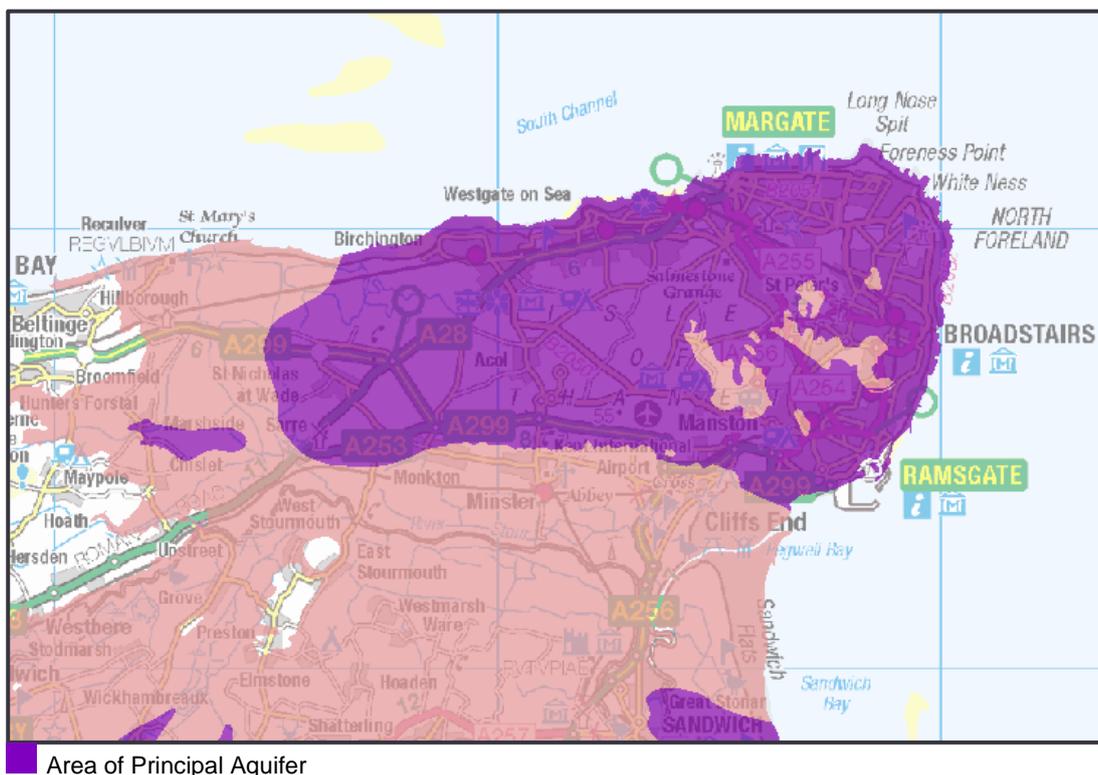
Figure 2.2 Designated SPZ

Inner zone (Zone 1) - Defined as the 50 day travel time from any point below the water table to the source. This zone has a minimum radius of 50 metres;

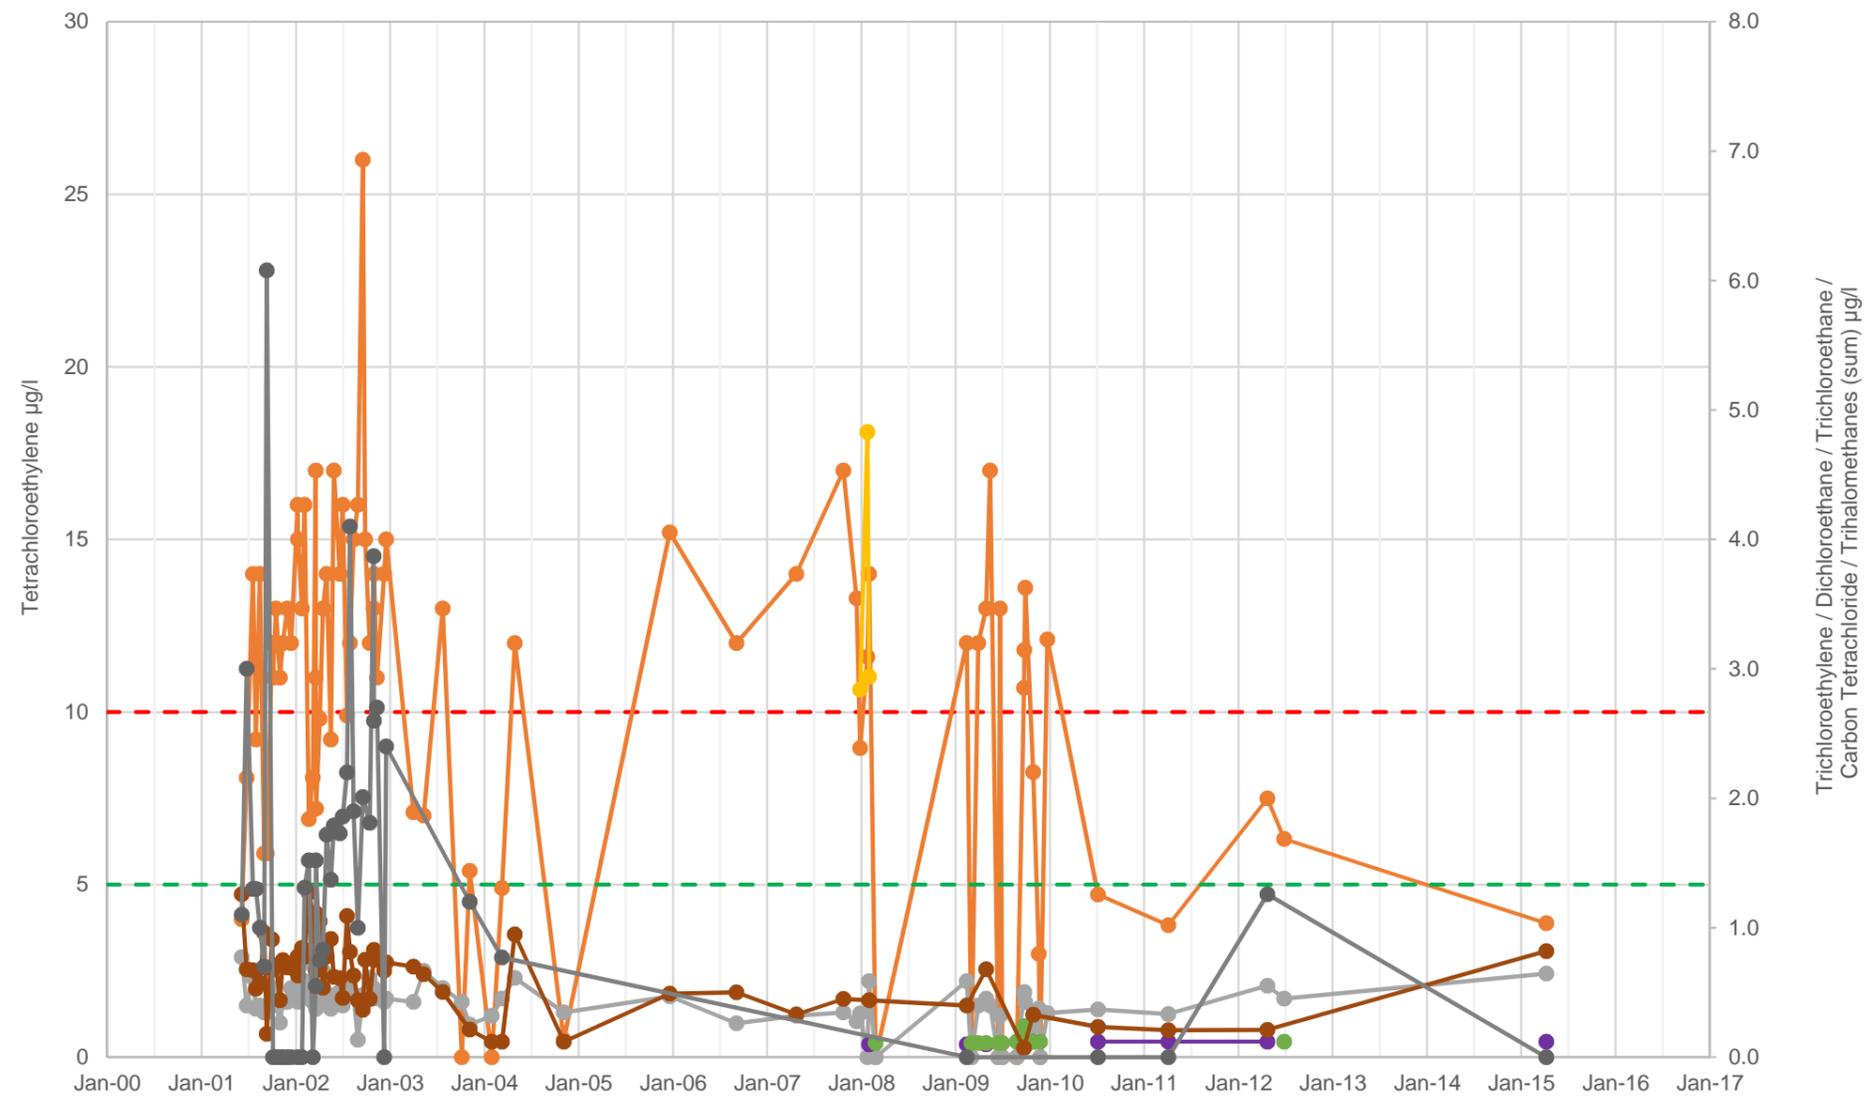
Figure 3.6
Solvent concentrations at Lord of the Manor

- Key
- DWS Sum of Trichloroethane and Tetrachloroethane
 - Tetrachloroethene
 - Trichloroethene
 - DWS Vinyl Chloride
 - Dichloroethane (1,2)
 - Trichloroethane (1,1,1)
 - Vinyl Chloride
 - Carbon Tetrachloride
 - Trihalomethanes (Sum of Identified THMS)

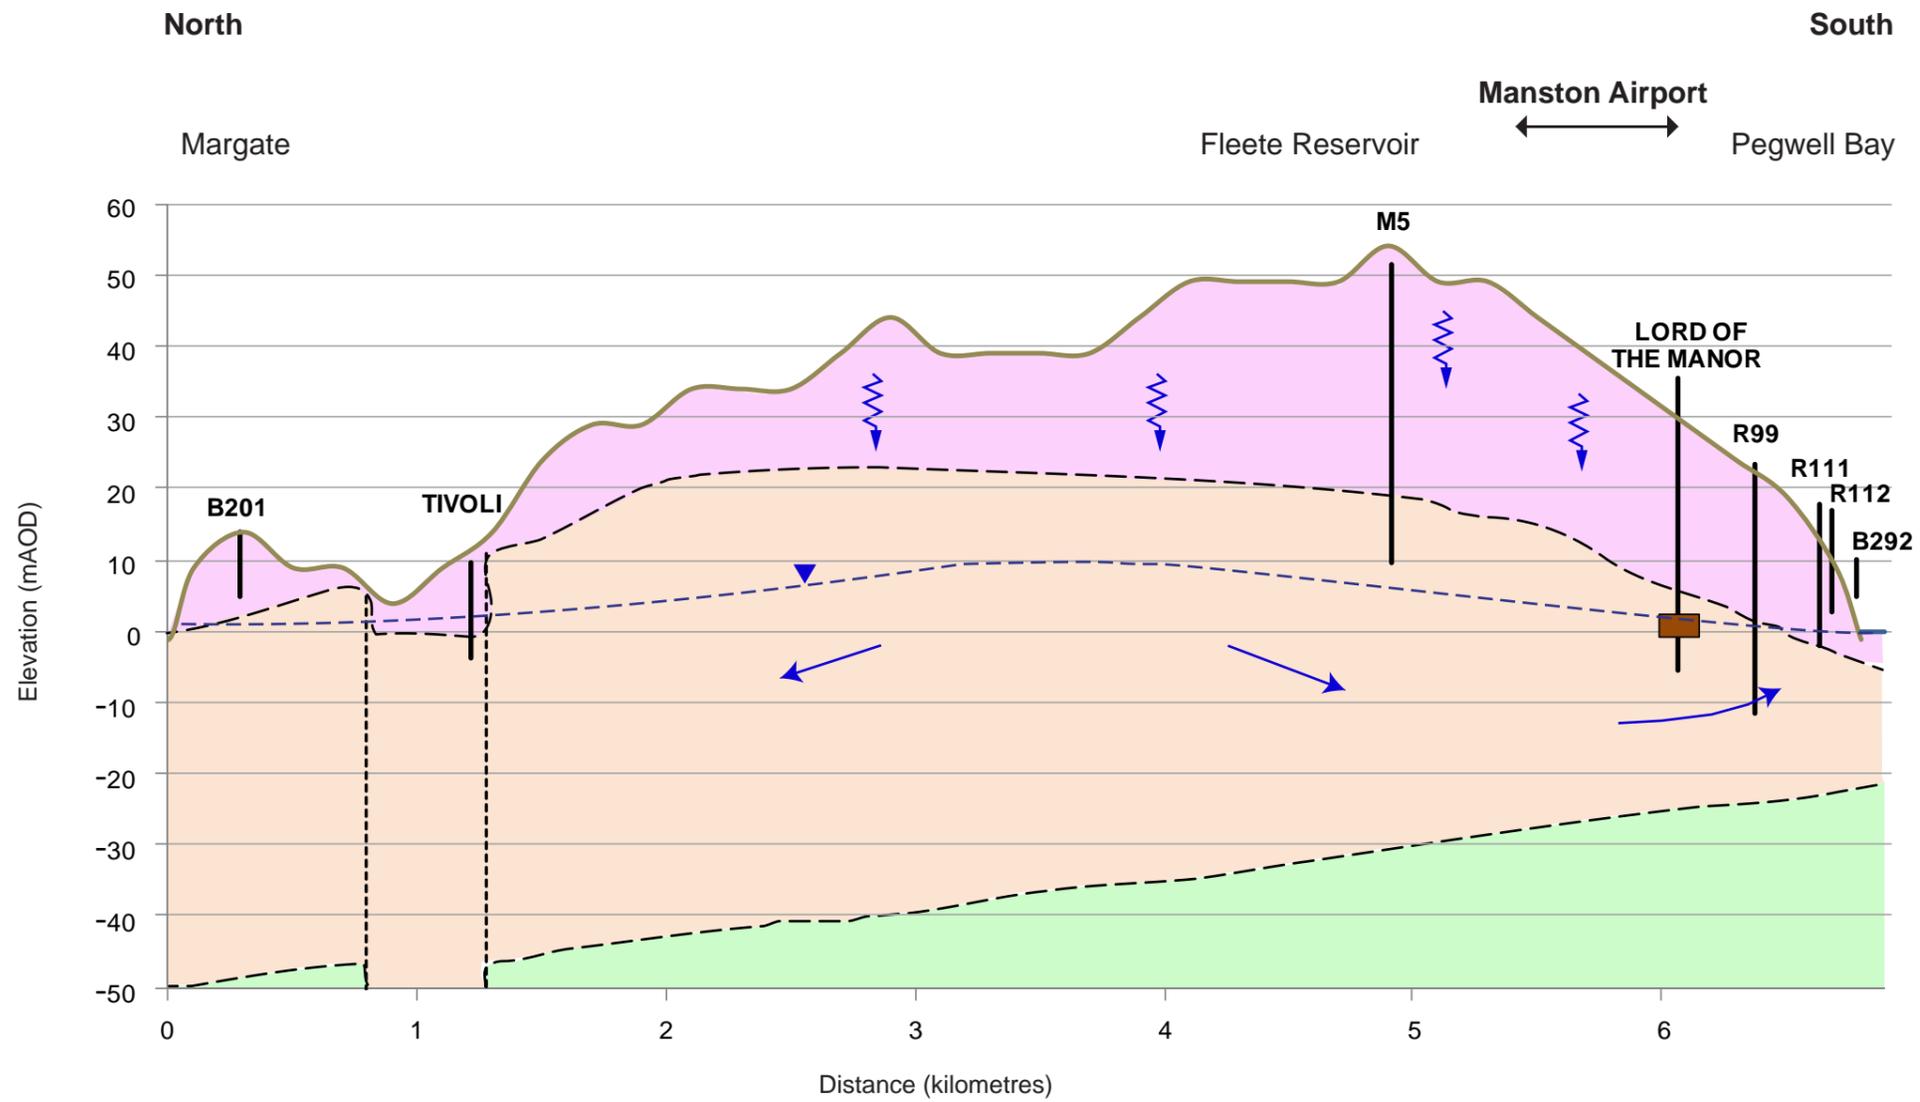
- Key**
- Ground surface
 - Newhaven Chalk Formation
 - Seaford Chalk Formation
 - Thanet Formation
 - Faults
 - Sea
 - Borehole
 - Ait levels (-0.7 - 2.8mAOD)
 - Water table
 - Groundwater flow direction
 - Recharge

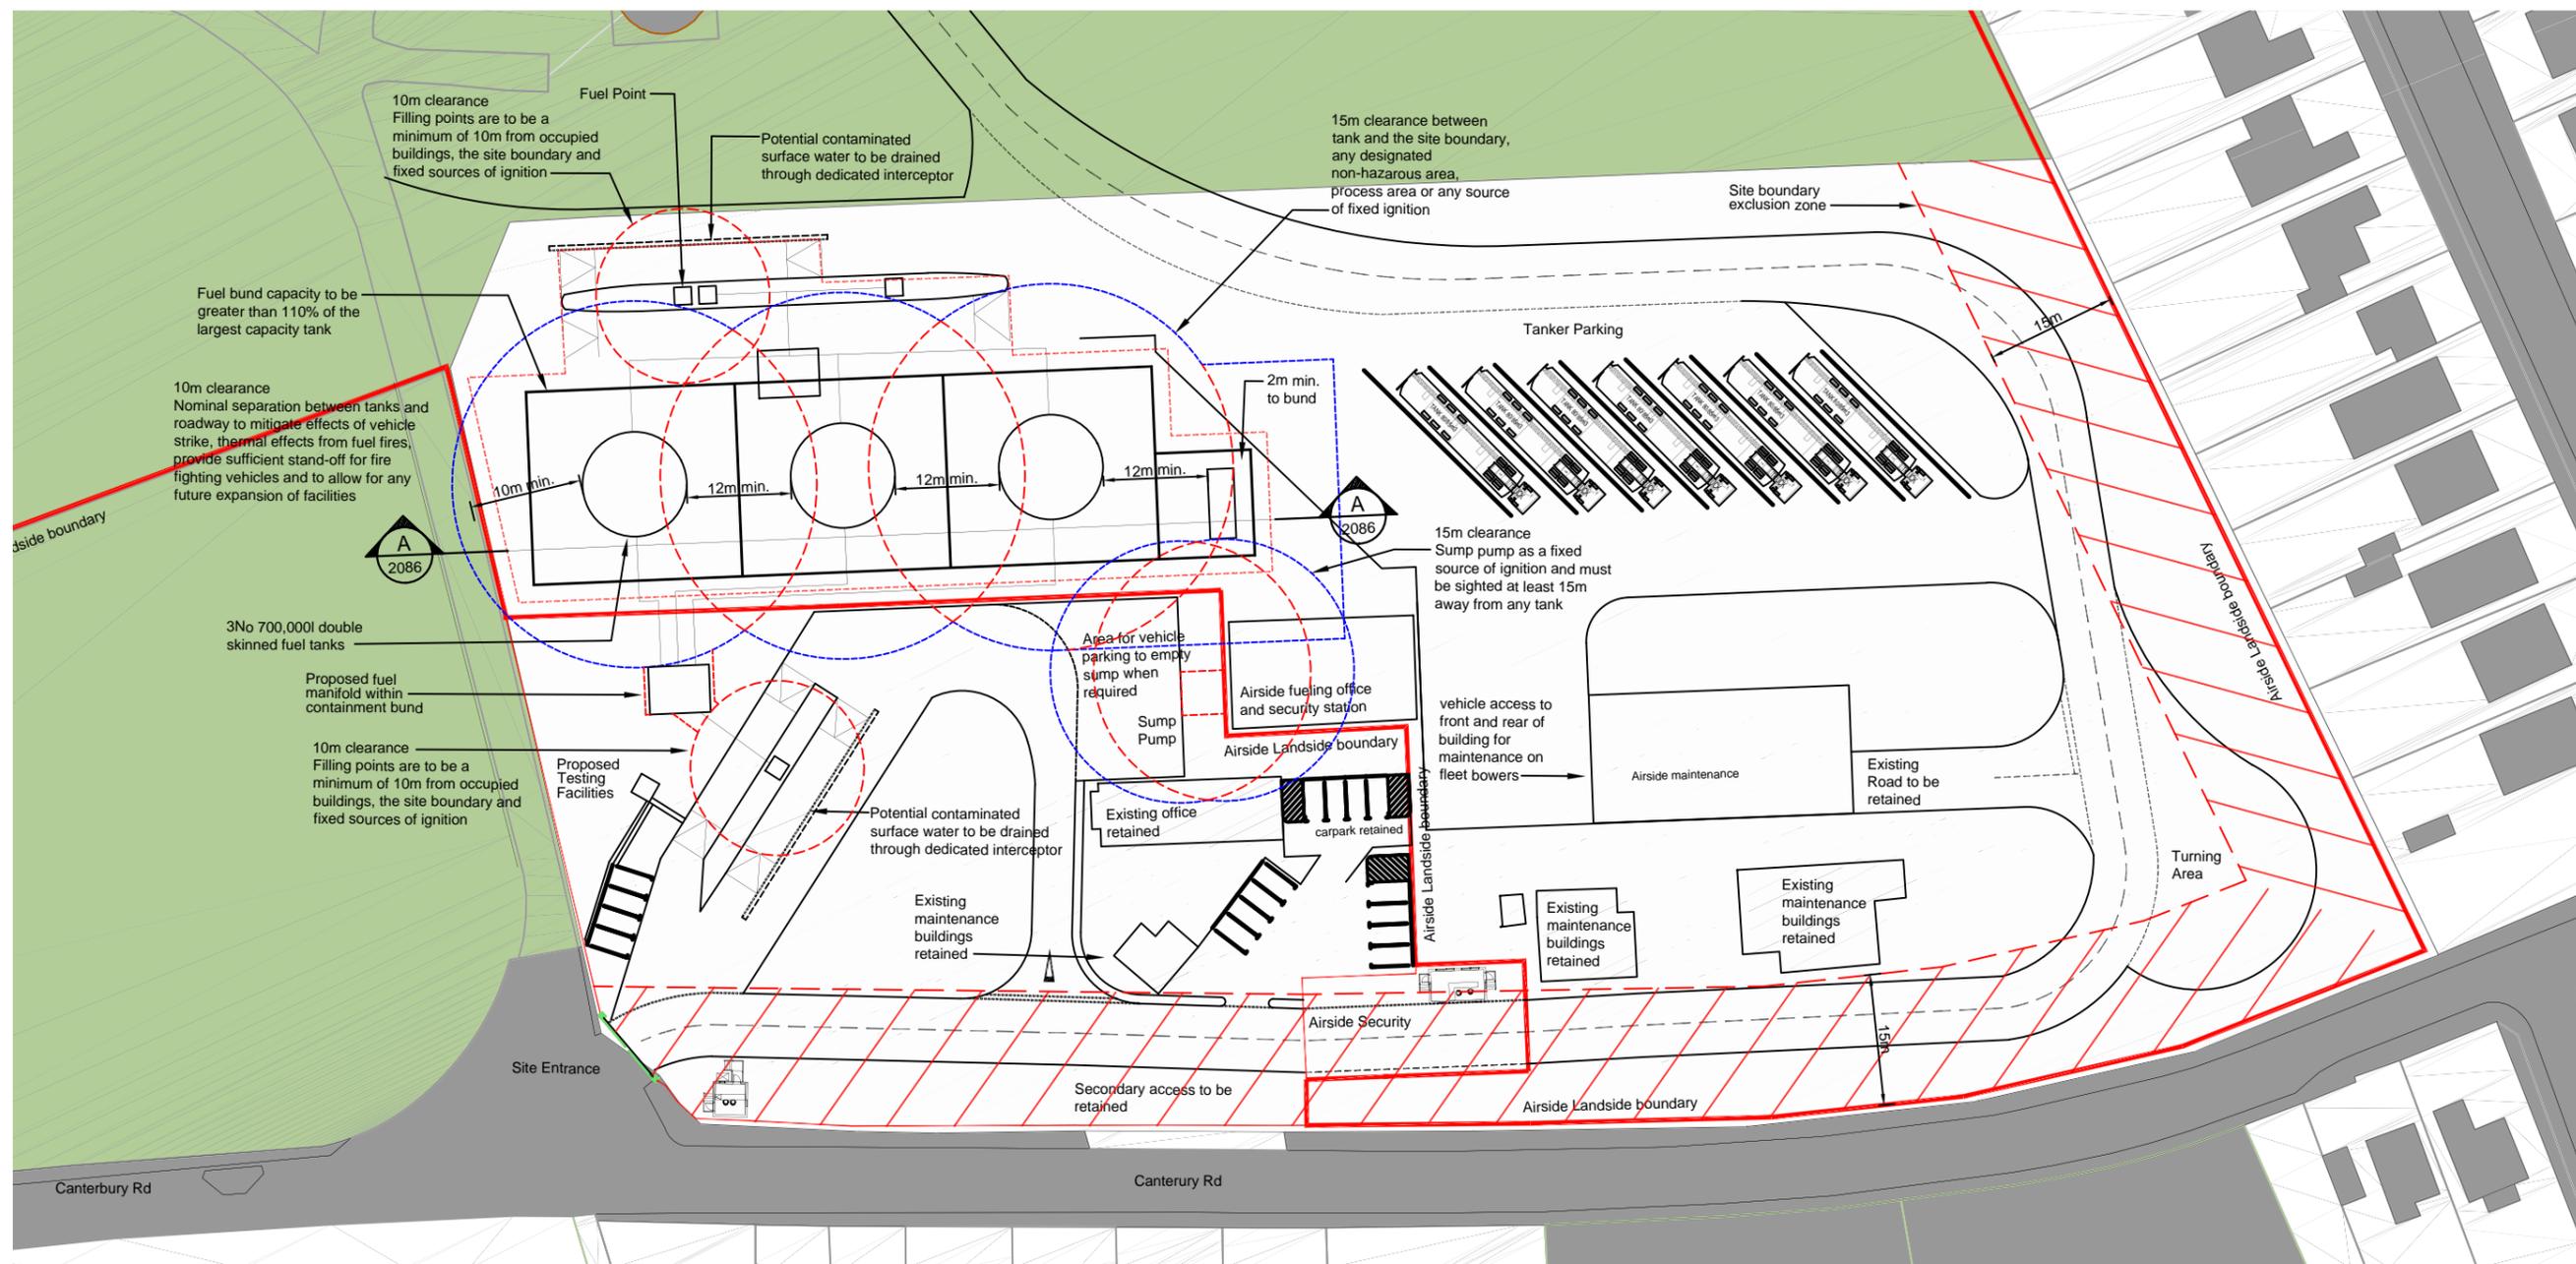
- Key**
- Airside / Landside Boundary
 - - - Enveloped Exclusion Zone
 - - - Individual Exclusion Zone

- Notes**
1. OS Data obtained from emapsite™ May 2017:
© Crown copyright and database rights 2017 Ordnance Survey 0100031673
 2. To reduce the risk of a discharge of fuel into public waterways, the fuel tank bunds have been provided with a sealed drainage system. All liquids in these areas will be contained within a sealed network. The captured discharge will be tested and either released into the drainage network or disposed off site by suitable means.
